# NASA-FAA Helicopter Microwave Landing System Curved Path Flight Test

H.N. Swenson, J.R. Hamlin, and G.W. Wilson

February 1984

## SUMMARY

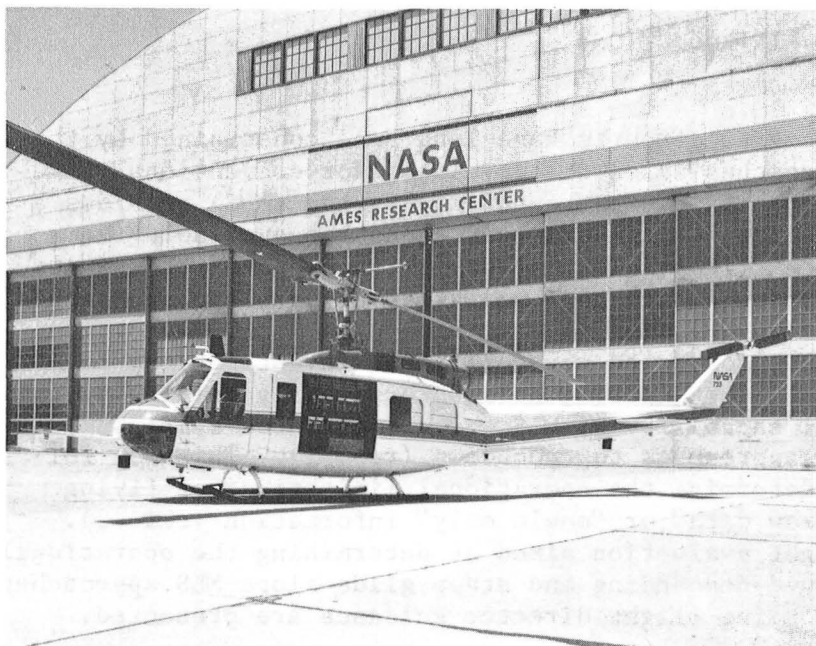
Figure 1.- Bell UH-1H.

The test aircraft was a Bell UH-1H helicopter (fig. 1). The UH-1H is a single-engine, turbine-powered, semirigid single rotor helicopter with a maximum gross weight of 9500 lb. The UH-1H is capable of carrying 11 passengers and two crewmembers and has a maximum airspeed of 125 knots and a cruise airspeed of 90 to 100 knots. The modified test aircraft performance and handling qualities are equivalent to those of a basic UH-1H operating at weights of 8000 to 9000 lb.

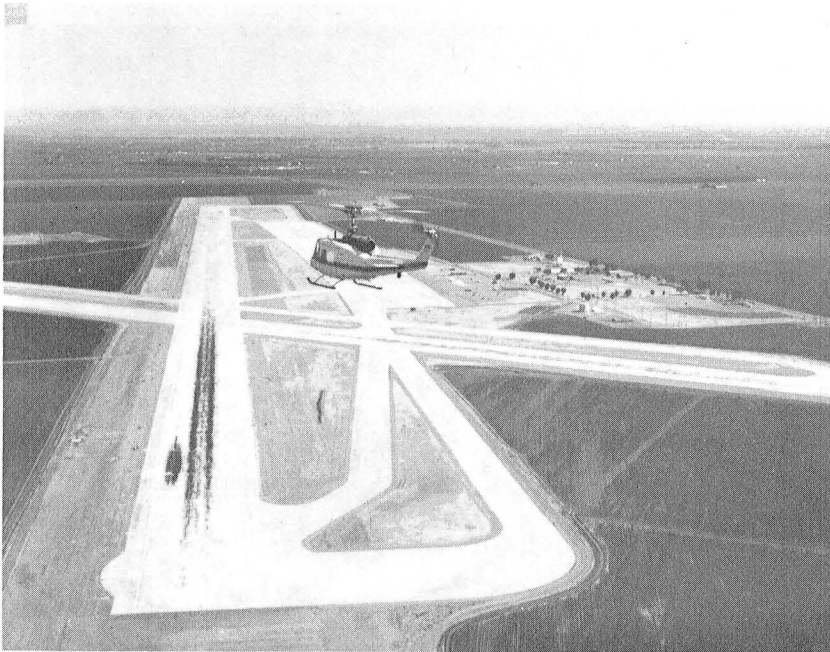
Figure 3.- Nine-degree glide-slope helicopter approach to Crow's Landing, Calif.

The flight tests were conducted at the Ames Flight Systems Research Facility at the Navy Auxiliary Landing Facility, Crows Landing, California. The hooded instrument helicopter MLS approaches, landings, and missed approaches were conducted to the STOLport located on runway 35 at the test facility. The MLS, located on runway 35 at the test facility, is a split sight system with the elevation transmitter located next to the STOLport which is painted on the runway, and the azimuth and PDME transmitters located 4473 ft beyond the elevation transmitter. The MLS is representative of a typical CAT II-type system which provides  $\pm 40^\circ$  azimuth coverage and  $0^\circ$  to  $15^\circ$  elevation coverage. The facility and the test helicopter conducting a  $9^\circ$  glide slope are shown in figure 3.
